1. AGENCY USE ONLY (Leave blank)	2. REPORT DATE 1996	3. REPORT TYPE AND DATES COVERED Final Report		
4. TITLE AND SUBTITLE The Old Hospital Complex (5EP1778) Fort Carson, Colorado		5. FUNDING NUMBERS

13. ABSTRACT (Maximum 200 words) <p>The Old Hospital Complex (5EP1778) at Fort Carson, Colorado, consists of 59 buildings. The Complex was built during World War II and is significant due to its association with the history of the United States. The complex is semi-permanent construction, constructed from the Department of the Army's Series 800 plans. This report documents the complex in accordance with Section 1(g) of the Memorandum of Agreement enacted among the Department of the Army, Headquarters Fort Carson, the Colorado State Historic Preservation Office, and the Advisory Council on Historic Preservation.</p> <p style="text-align: center;">DTIC QUALITY INSPECTED 2</p>

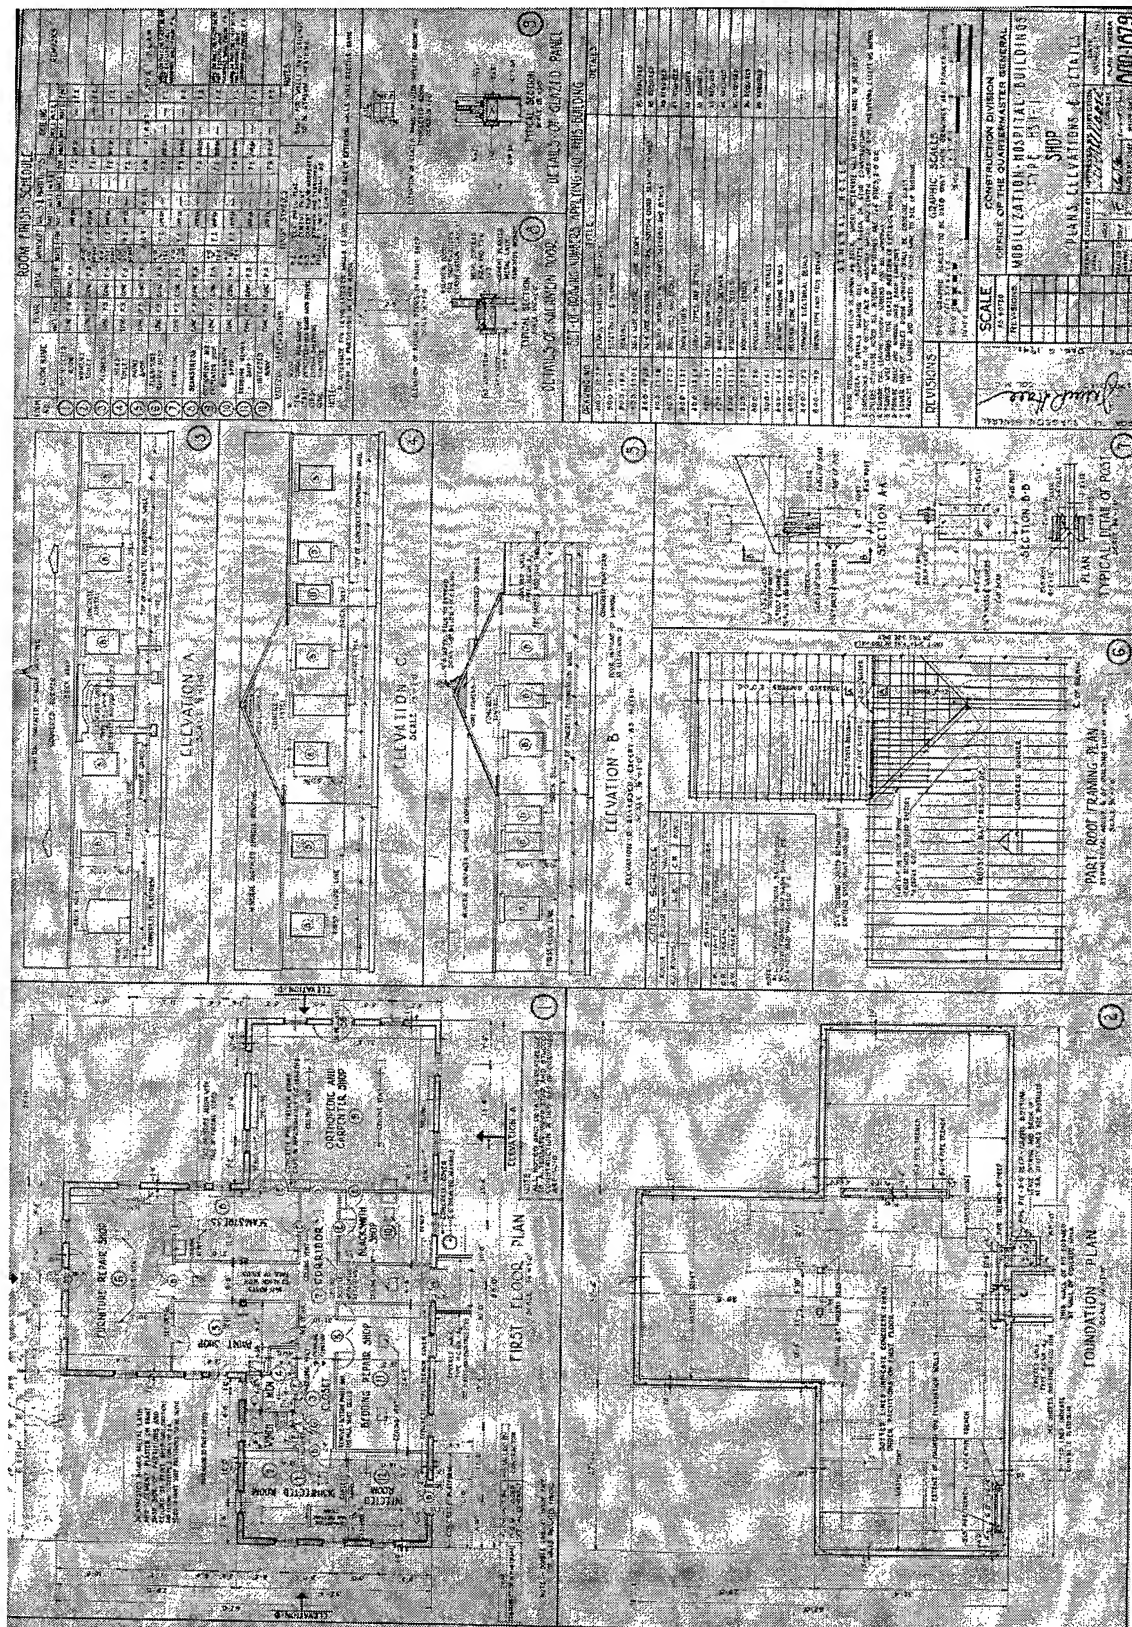
Figure V.242 5EP1778. Plans, elevations, and details for Building S6274, Shop, 800 Series, Type HSH-1, Plan 800-1879.

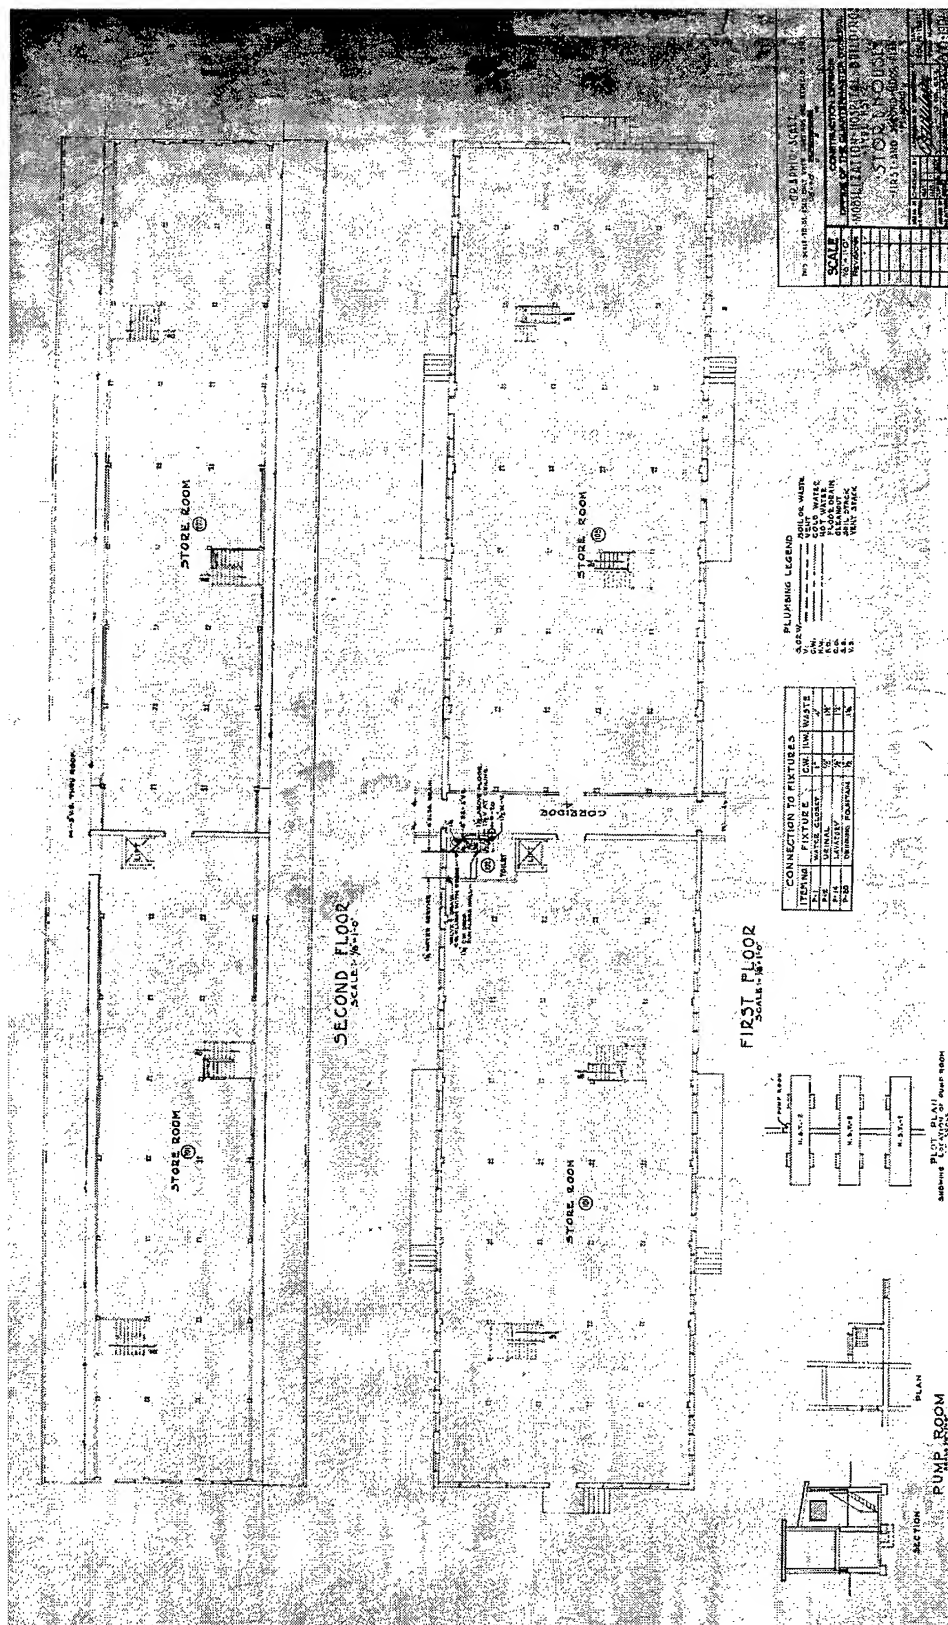
Figure V.258 SEP1778. First- and second-floor plumbing plans for Building S6271, Storehouse, 800 Series, Type HST-2, Plan 800-1901.

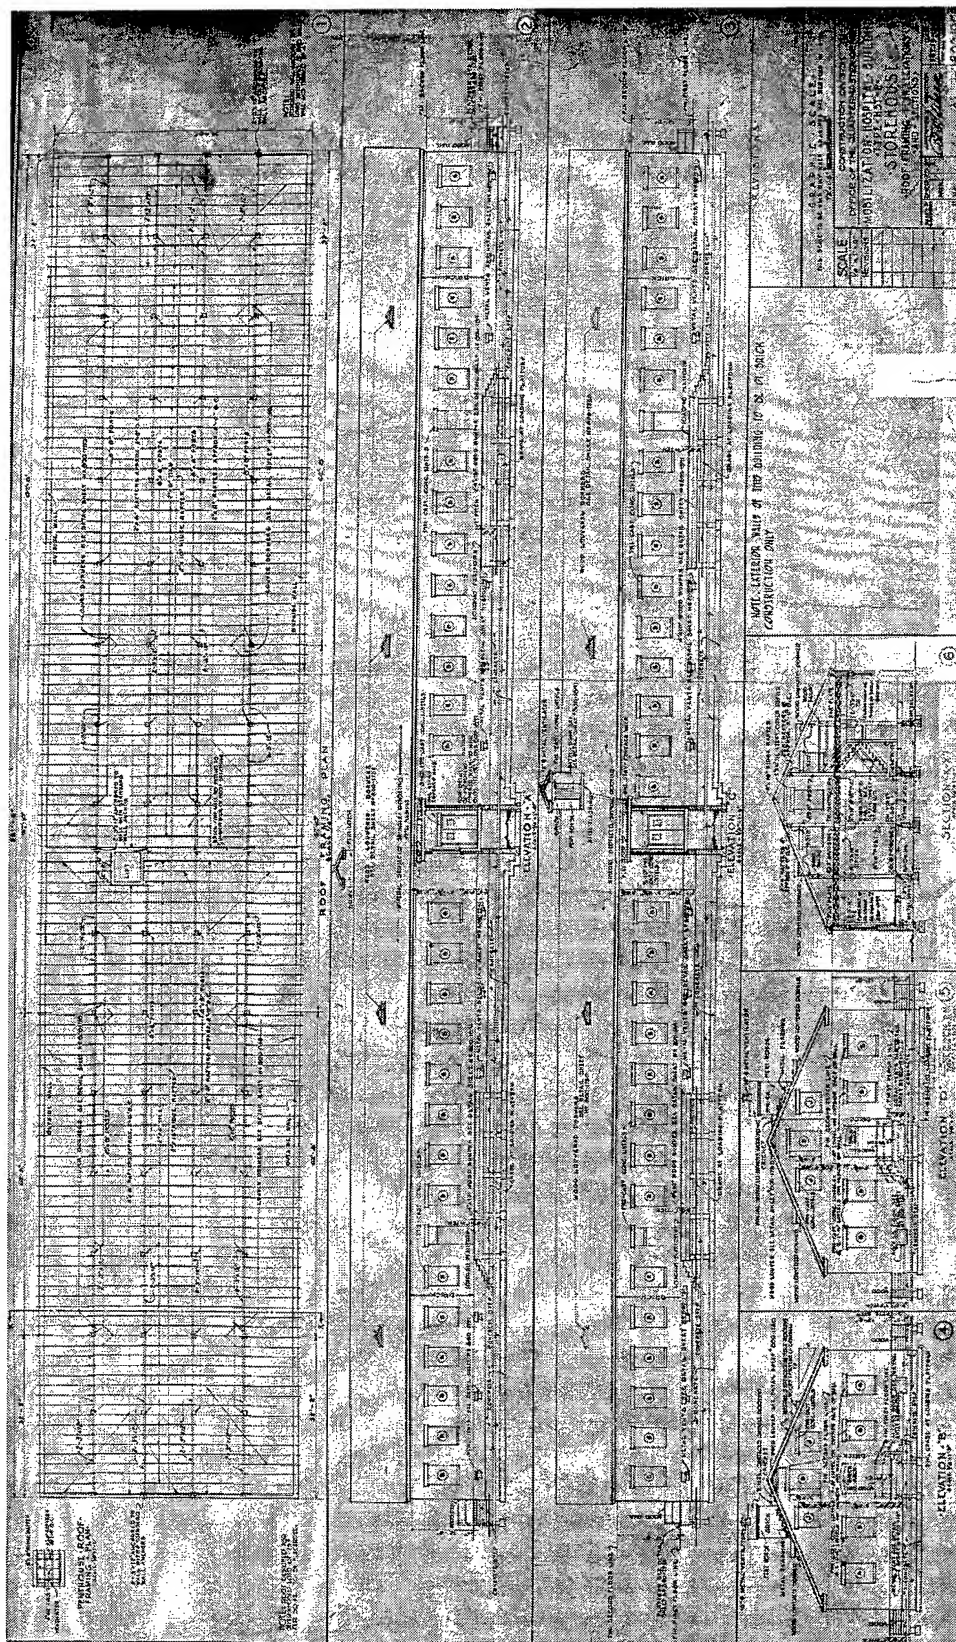
Figure V.259 5EP1778. Roof framing plans, elevations and sections for Building S6271, Storehouse, 800 Series, Type HST-2, Plan 800-1900.

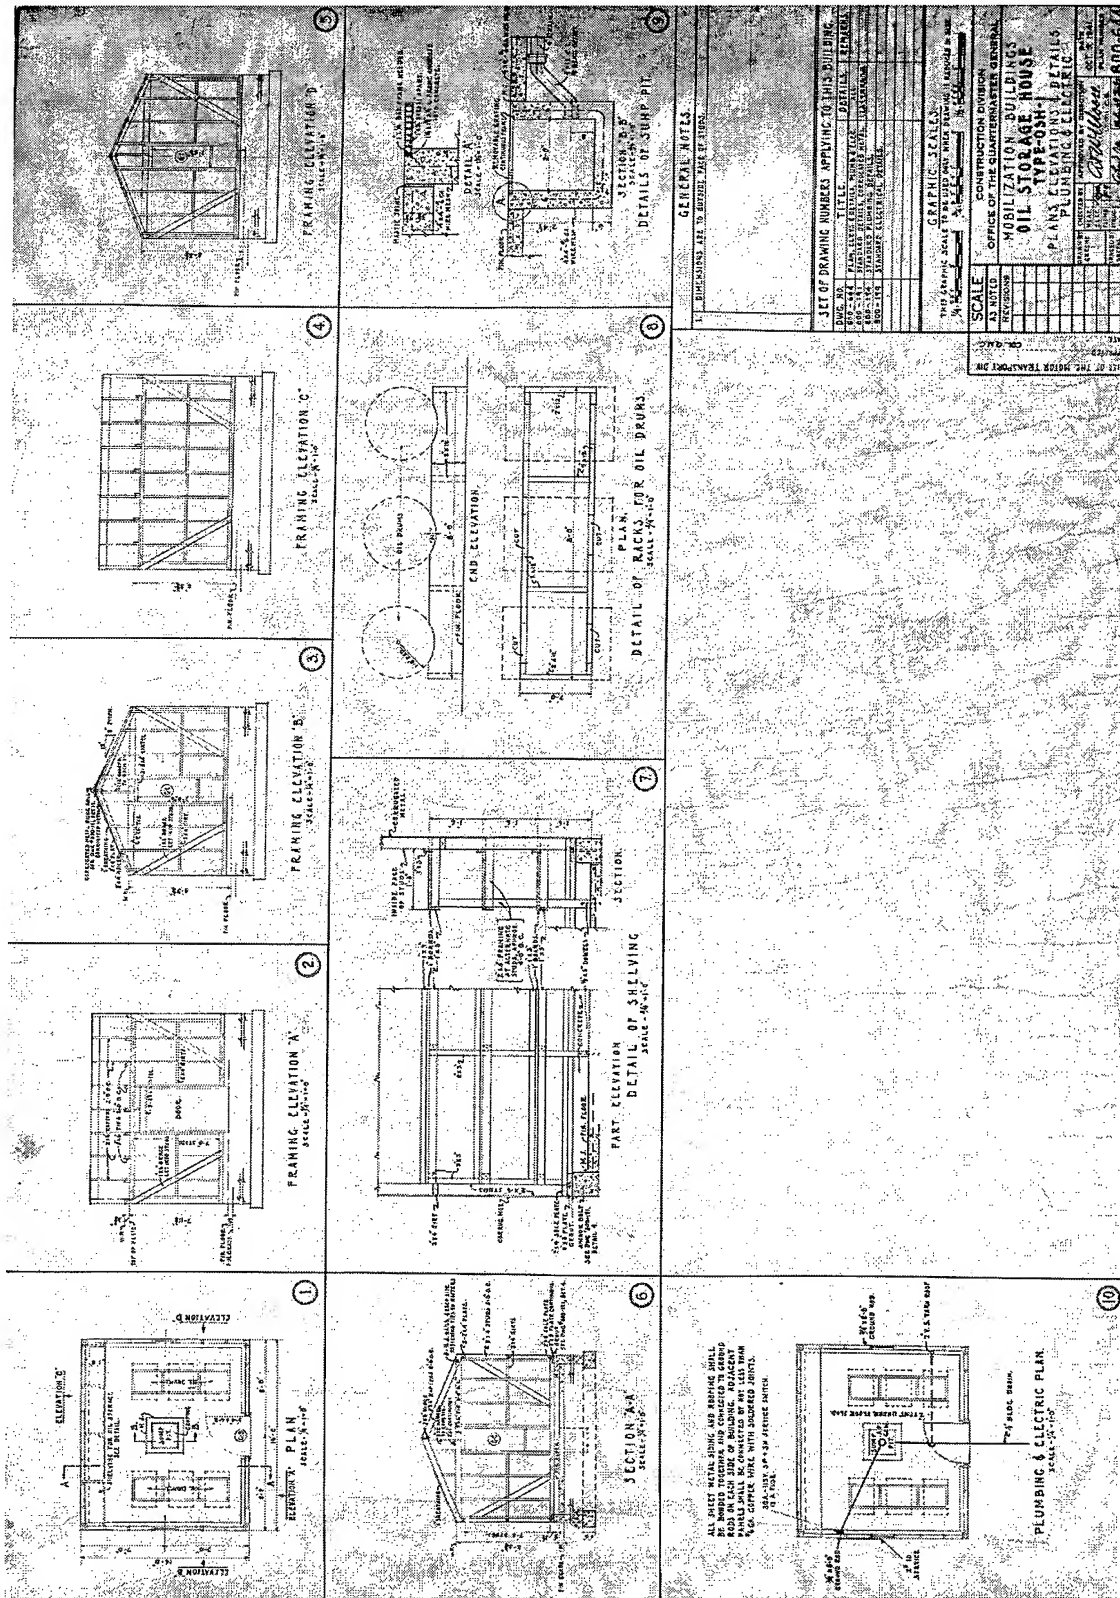
Figure V.276 5EP1778. Plans, elevations, and details for Building T6289, Oil Storage House, 800 Series, Type OSH-1. Plan 800-644.

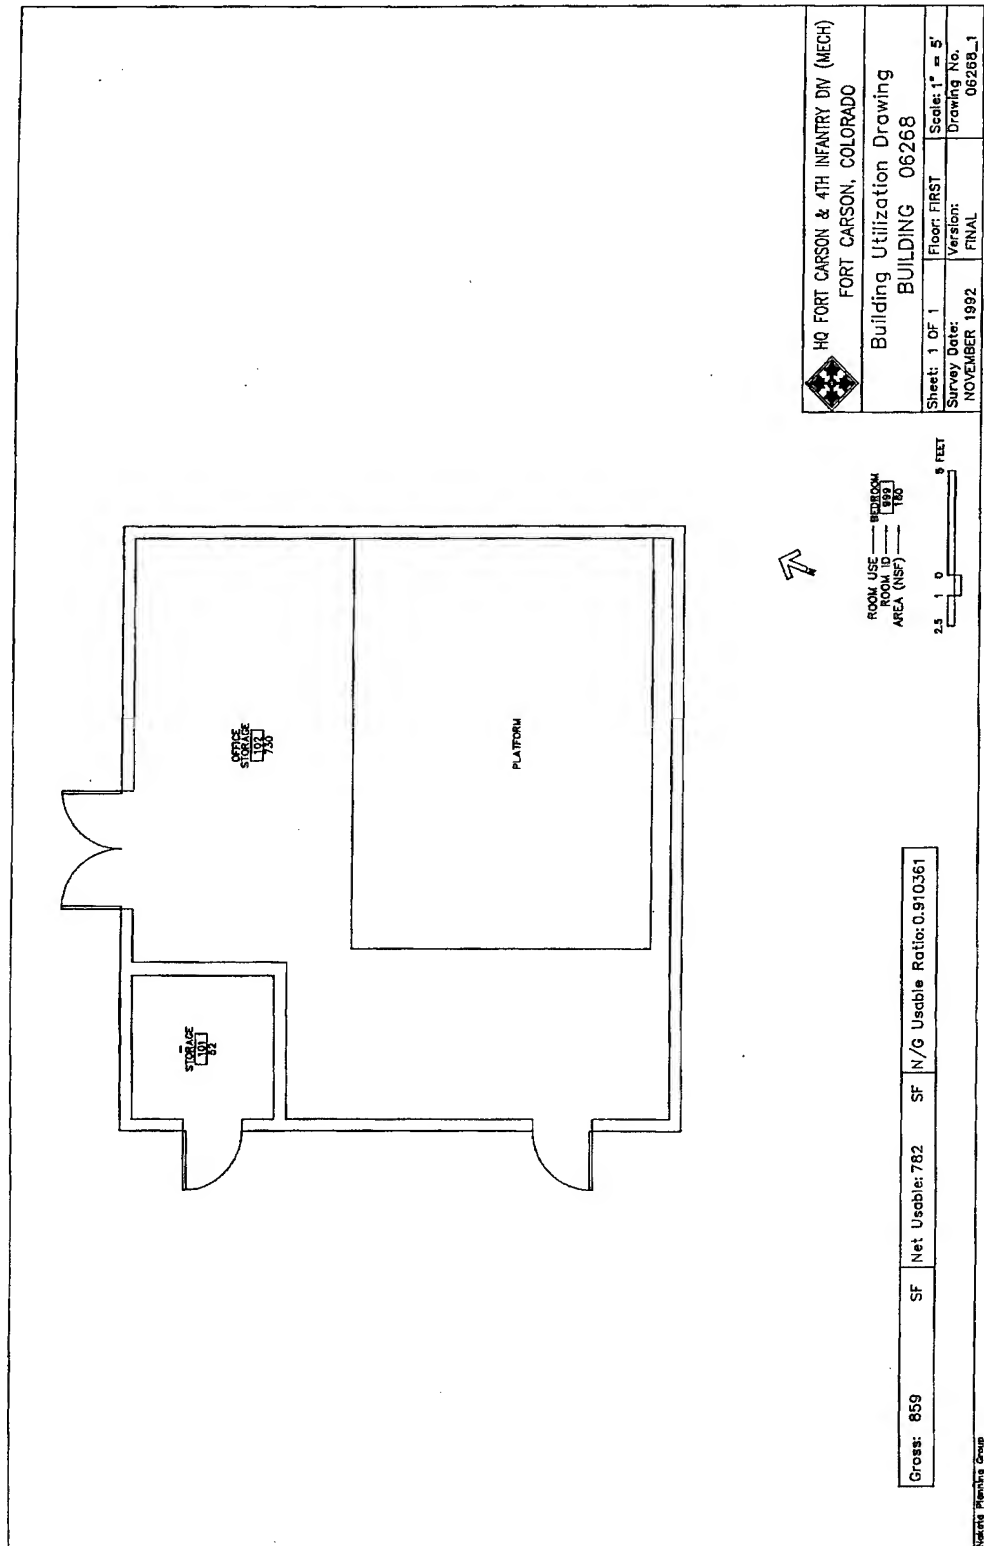
Figure V.277 5EP1778. Floor plan for Building P6268, Standby Generator Plant. BUD Series, dated 1992.

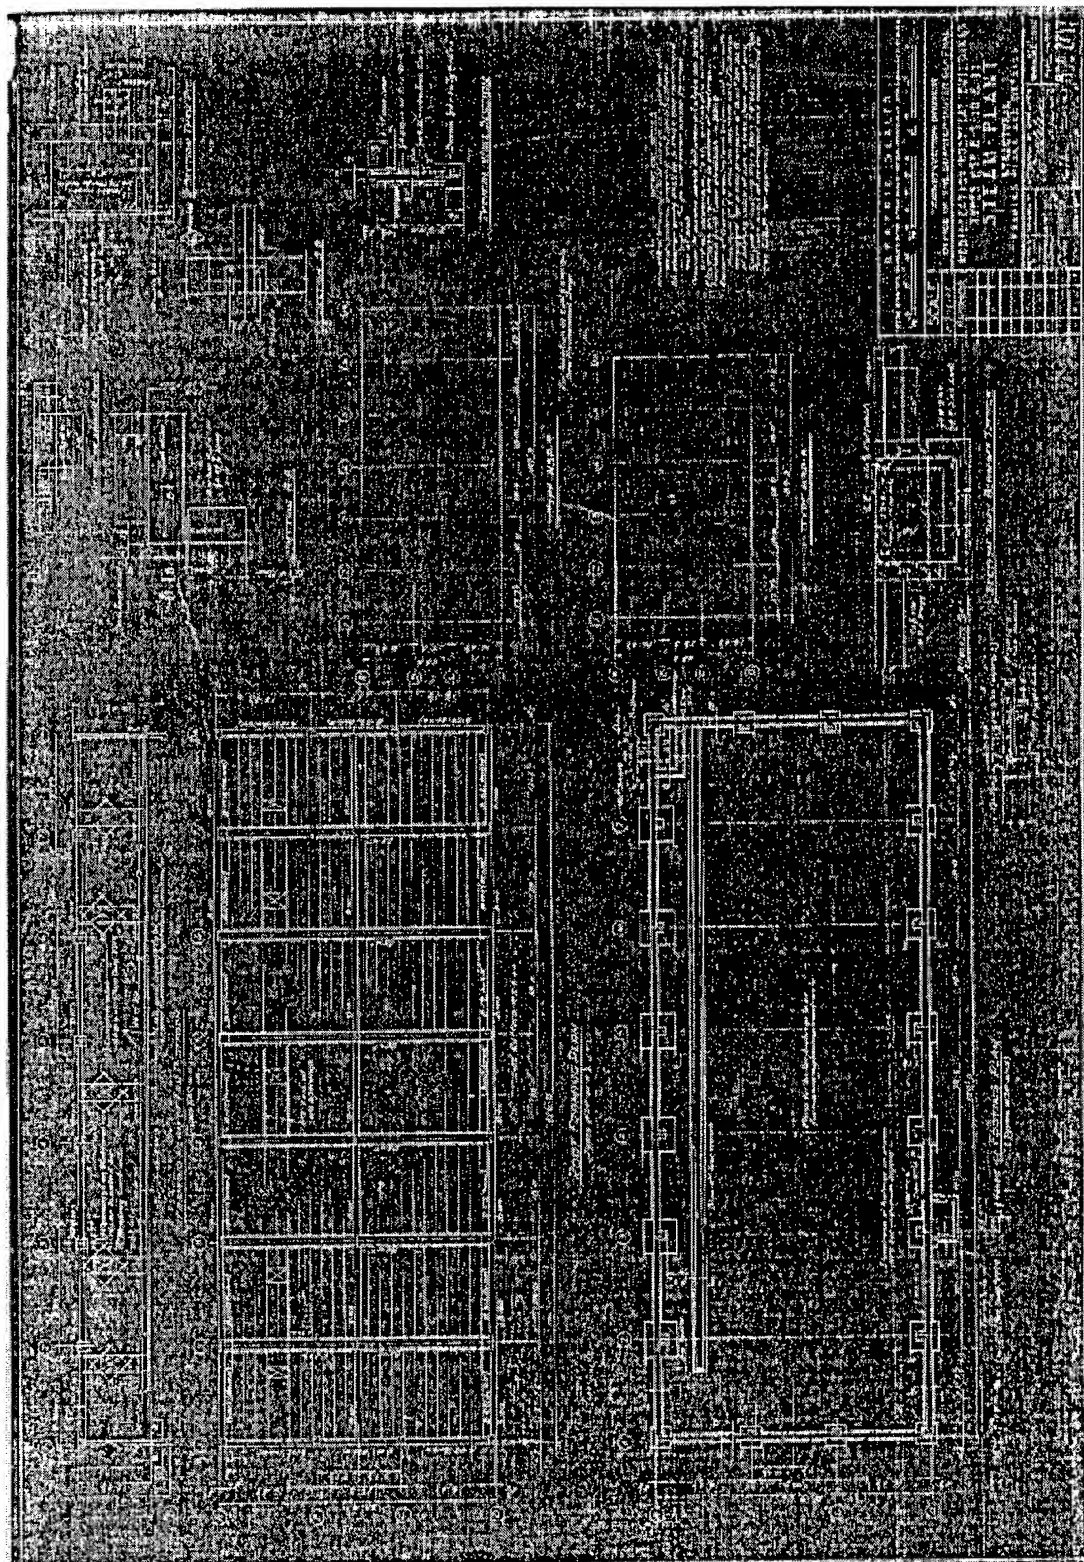
Figure V.279 SEP1778. Structural framing plans and details for Building S6290, Steam Plant, 800 Series, Type HSP-8, -9, -10, and -11, Plan 800-2217.
